Earth Sciences for Civil Engineering Part-2
Professor Javed N Malik
Department of Earth Sciences, Indian Institute of Technology Kanpur
Active faults and its related hazard in India (Part-5)
Module 2
Lecture No 8

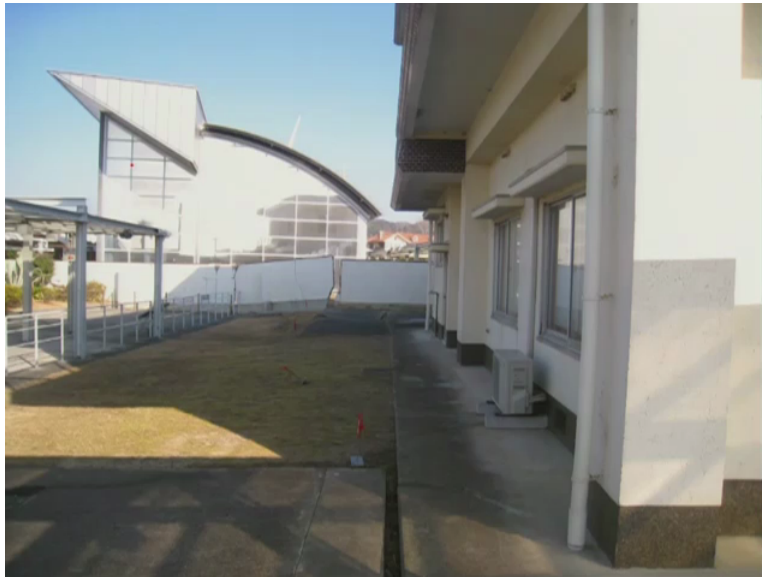
But even though there is no other alternative if we have to cross the structure and we have to put the structure on that, so we need to understand that what will be the movement and what type of displacement it will result in when there is an earthquake. So this is an example which shows that there if if you look at this wall here, this wall got displaced at the time of the earthquake in 1995 Kobe.

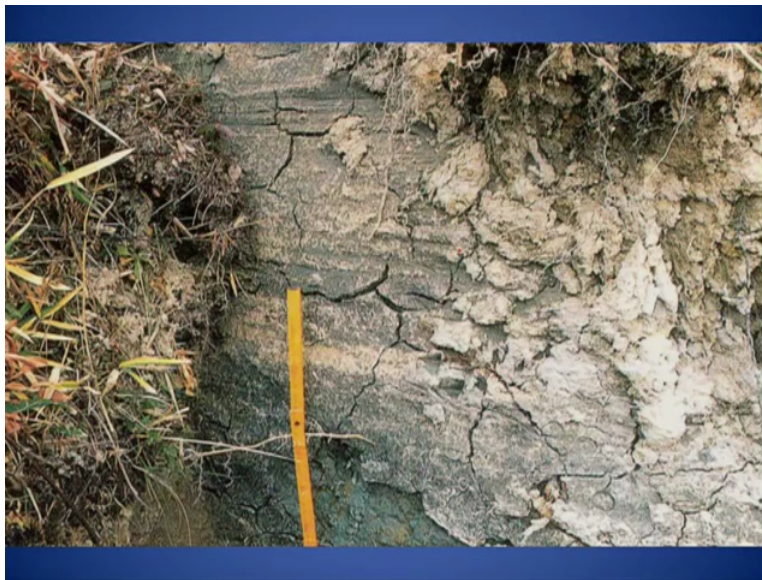
So this what it shows is the striations, this indicates again that in the direction the fault moved, so if you see clearly here there are very fine striations or the polish surface which was resulted because of the the movement and the wall moved like this ok, so direction of the movement is like this.

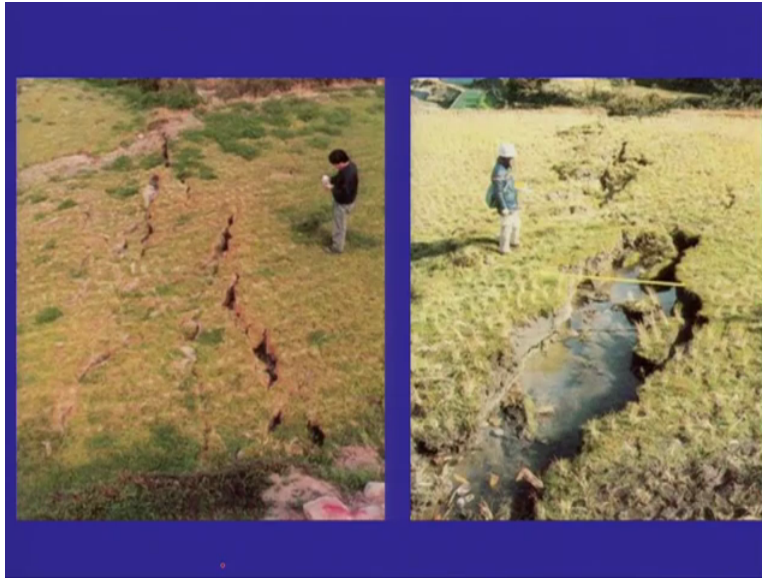
So several small scale fishers were also developed along with that and most common phenomena which is what we call as a secondary phenomenon mostly seen in or observed during an earthquake is liquefaction and lateral slip, so lateral spirit or lateral slip of the land is also another commonly seen affect and those are secondary effect ok, so other than the faulting which is resulted on the surface or the the fault scarps which are seen on the surface.

Because of strong ground shaking you will be able to observe or experience the land slip which is if you are having a very low angle slope than also you can have that and then the liquefaction ok. So this is an example which you see here is of lateral spirit, in a proper sense we can say is a is a land slide ok and then we have liquefaction occurring.

So along the fishers we will have the liquefied material which is coming right up to the surface and this is extremely dangerous because if you are having a structure sitting on such soils ((12:03)) than the that structure will collapse because the soil will lose the shear strength, so in Indian in particularly if you are having a big earthquake or large magnitude earthquake in Himalaya, lot of problems will be faced in terms of liquefaction in the Indo Gagenic plane because we are sitting on a loose soil, we have the very and and the water table is also very low ok. So we we will have liquefaction problems in the Indi can city plane.

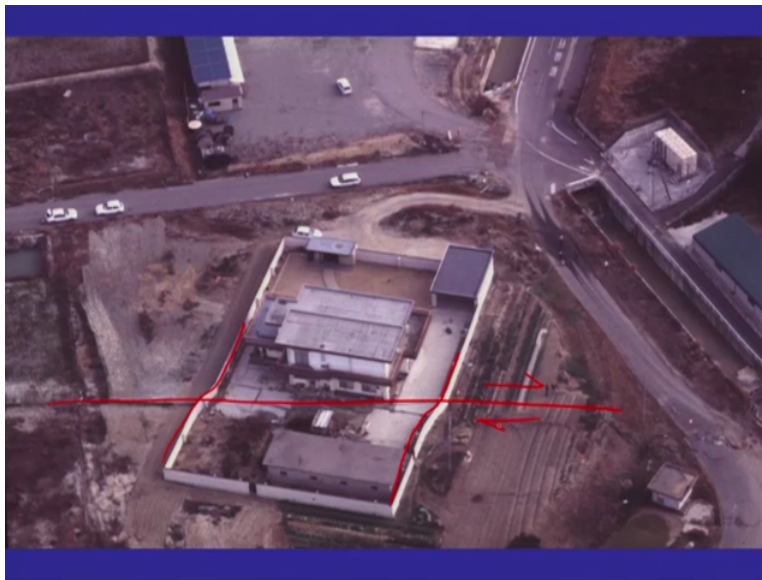
And they also took up, took this house which is now a part of the museum and you can see this, the rupture is going over here like this and then there is a displacement which can be seen over here ok, so this this boundary wall got displaced right laterally, so if you can put here like this than it goes like that ok. So fault runs here, so you are having the movement like this here, so this

is important like we we need to know where exactly the fault goes, so we should avoid putting structures on such fault lines.

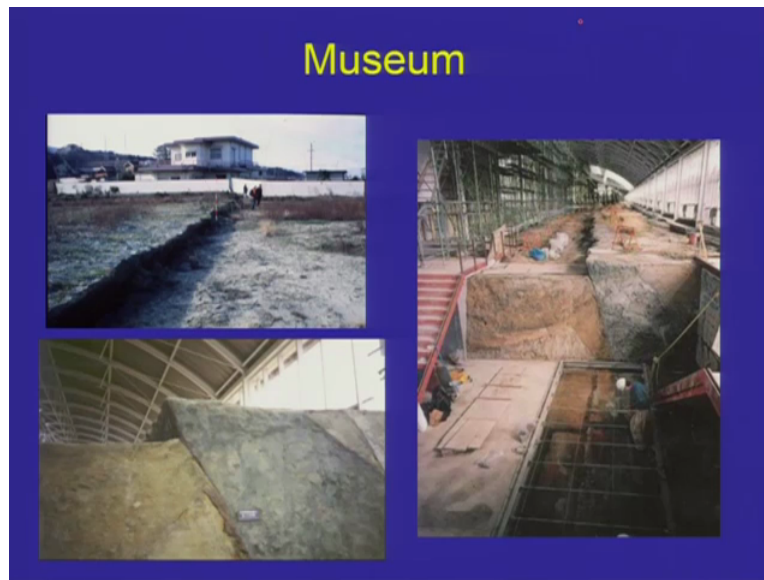
So this part goes into the museum, so they excavate it trench which shows the section view, sectional view of the fault and to show the people ok, so they have like they have the this is the rupture coming up and this is the sectional view and then this is the horizontal view of that ok, so they dug this and they have preserved so they put the glass on this one, so the people can walk down and move on the on the on the fault itself and try to understand what exactly happen ok.

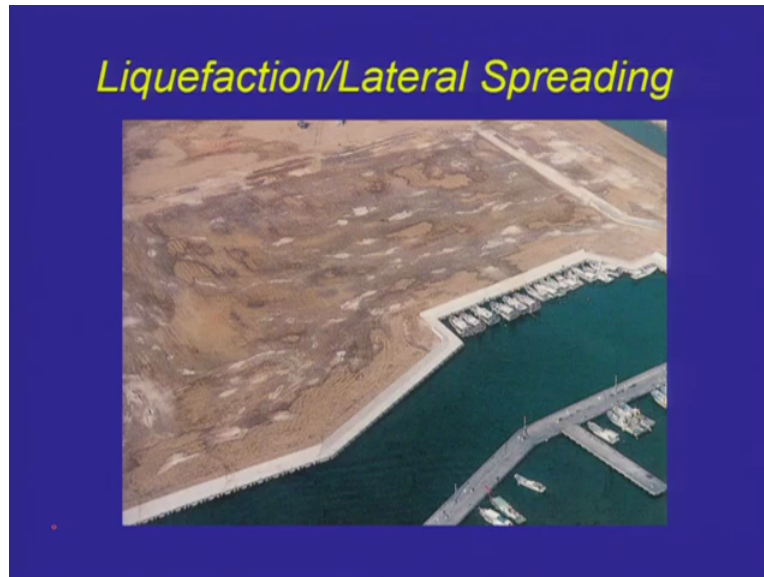
Now liquefaction and lateral straight was very common in the areas and the costal zones where they reclaim the region ok, so this is the reclaimed areas where we can they had massive liquefaction, so all white spots which you see here are the liquefied sand which came up through the through the sand pores.

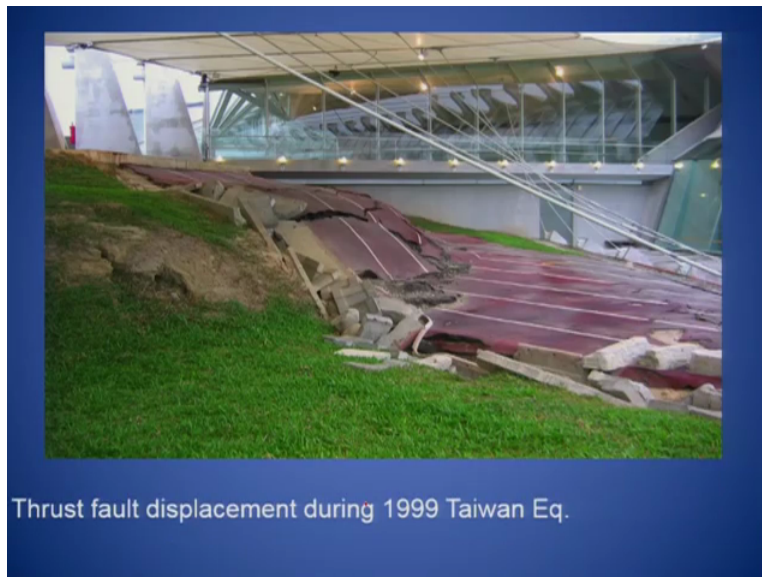
There is another example of 1995 Chichi earthquake, we can see that the fault passed through the the playground and the the running track was been warped ok and this is a typical fault scarp which one can expect during the reverse fault or thrust fault earthquake.

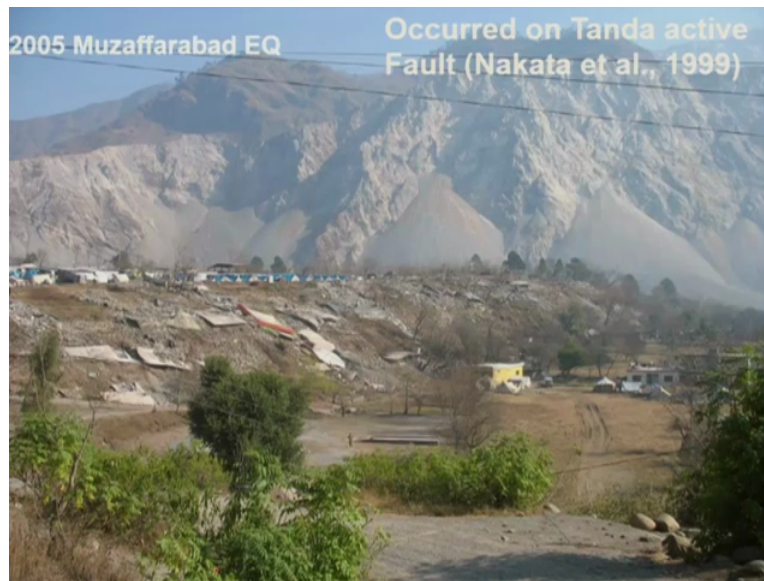
And coming to this ok, this is another one which occurred in 2005 ok. Now there is a small story behind it that this fault scarp which you see now here ok, was been identified by the by the professor which I was showing in the video Takashi Nakata, he identified in 1999 named that Thanda fault. Now this report was been submitted to the geological survey of Pakistan and he categorically mentioned that this fault may trigger a large magnitude earthquake in near future but they didn't believe him because they said oh fine, this is only 16 kilometre, 13 to 16 kilometre long fault how it can trigger a large magnitude earthquake.

But based on his experience and the work which he has been carrying out in Japan and India since last 30 to 40 years he mentioned that ok and and this what we experienced in 2005 was Muzaffarabad earthquake, the same fault ruptured and we had lot of life lost ok. So this is a fault scrap which can see and most of the this the flat line structures are are the the houses which were been raised to this ground during an earthquake, this so this is an hanging wall this is an foot wall here.

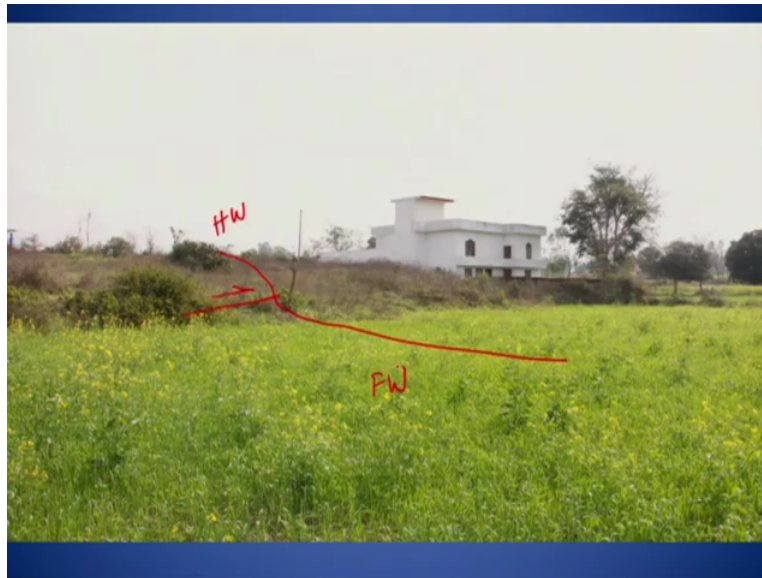
Another example from India, at this what where we have been working as a part of the project sponsored by the ministry of earth science on active fault mapping in Himalaya, so this is another scarp similar to what we I was showing in Pakistan Thanda fault, this fault we have named as Hajipur fault and this is this exist on on the lift bank of the Vyas river. So you can see the uplifted part here, so there is a this if I just put a profile here, it will be something like this ok, so this is, there is a fault here which has moved like this ok. So this is an hanging wall and this one is the foot wall.

So probably because of the the less awareness people have built the houses here ok, so when we were doing our work in this area, people asked that there is no problem ok, only one house has been built on this but the point is that so more people will come around and have their houses here, so one guy came, another guy will come and they will have more houses on this but this but this should be stopped ok. So this is fault an scarp, Hajipur fault scarp and fault runs somewhere over here ok.
